February 22, 2016

**RE:** *ELIZABETH II*  
**DOC:** USCG # CG052036  
**HULL#:** NC2007320783  
**TYPE:** 16-CENTURY MERCHANT SHIP REPRODUCTION

### **SURVEY SUMMARY**

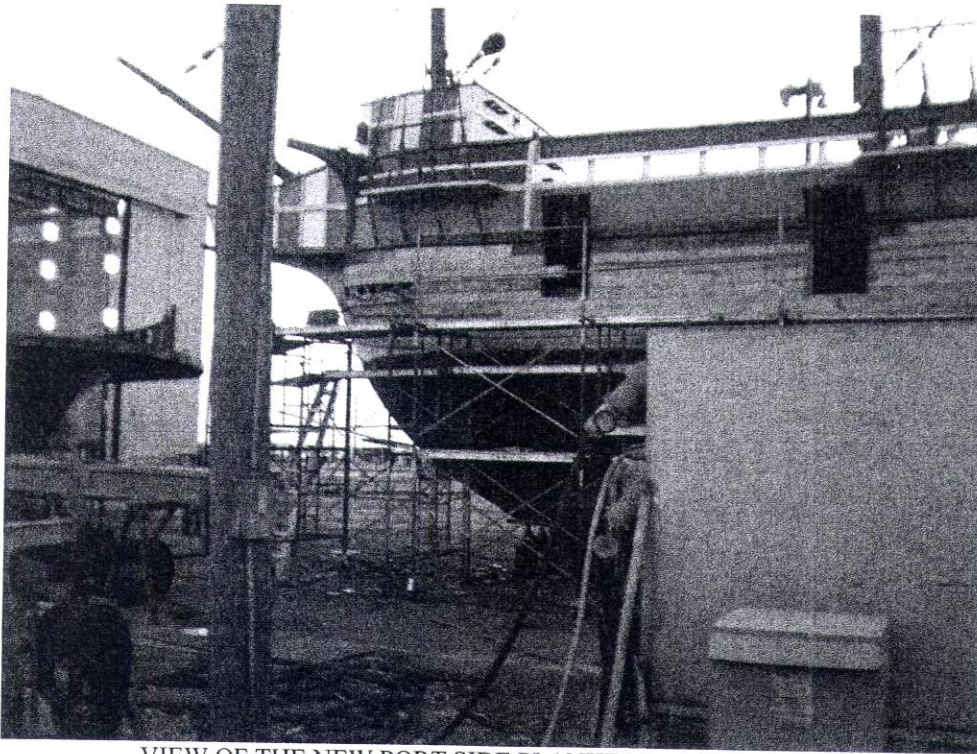
VIEW OF THE NEW PORT SIDE PLANKING – PARK PHOTO

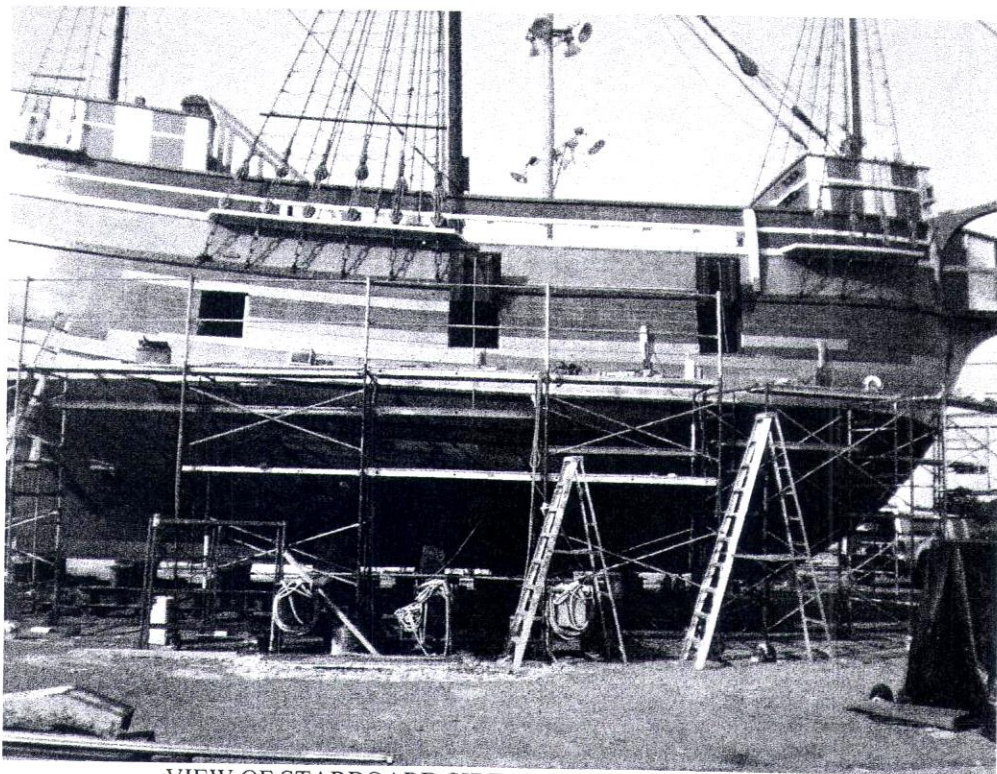
VIEW OF STARBOARD SIDE PLANKING – PARK PHOTO

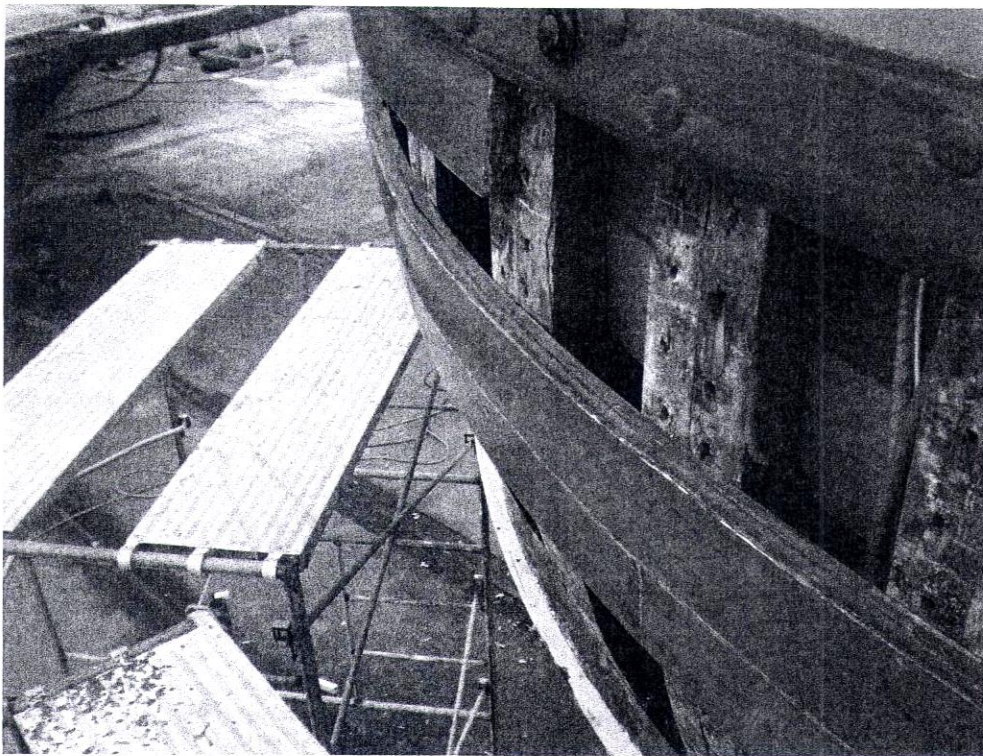
CLOSE UP OF FRAMES – PARK PHOTO

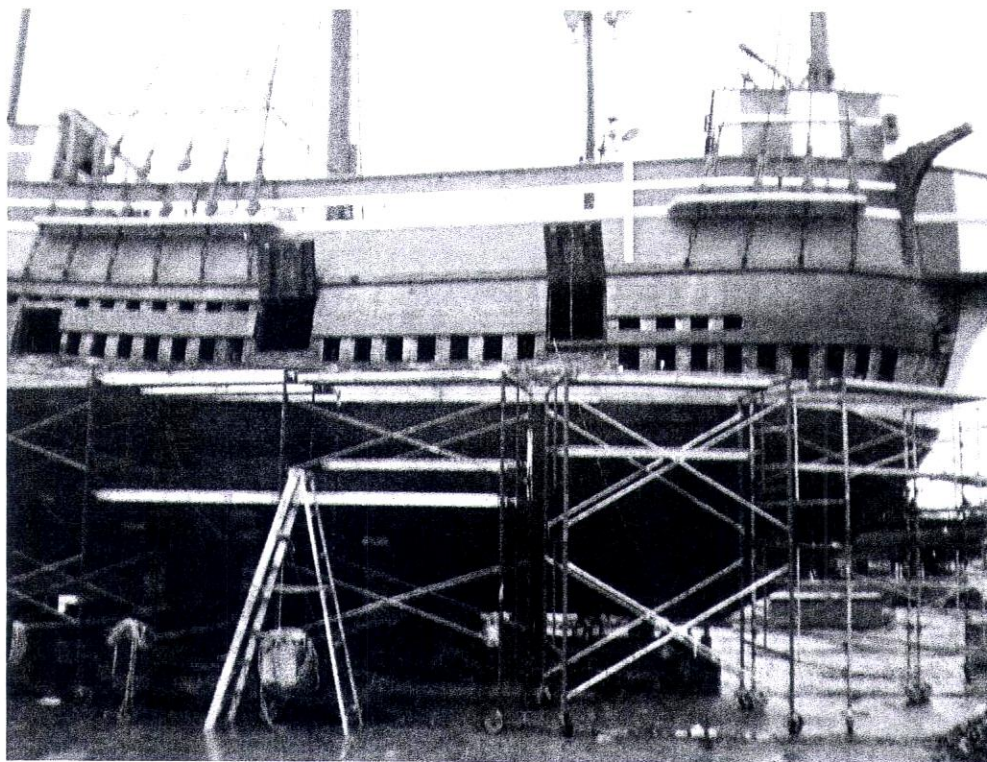
VIEW OF STARBOARD FRAMES – PARK PHOTO

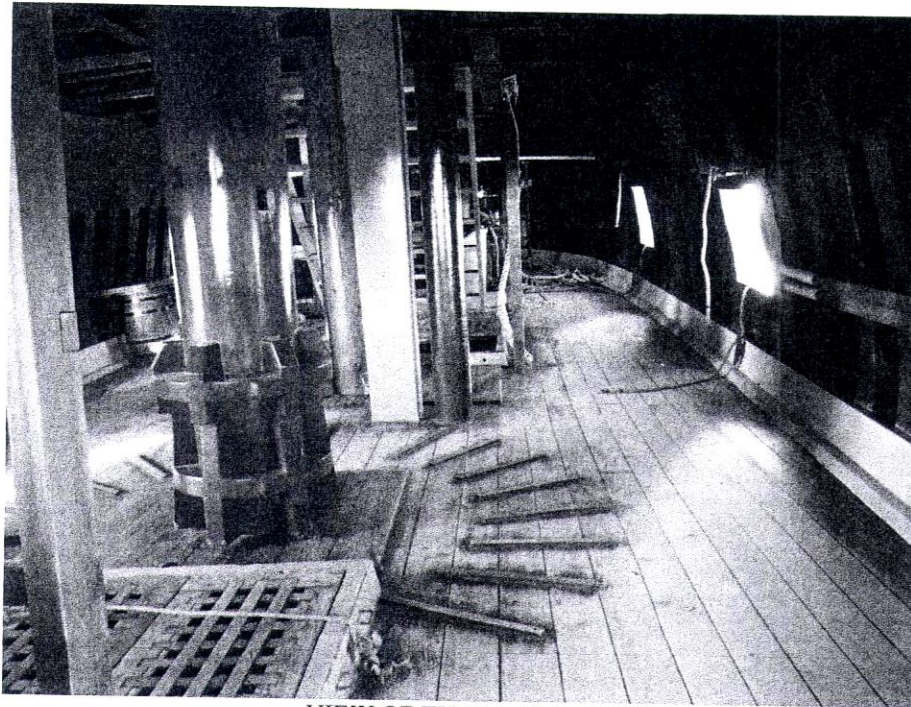
VIEW OF THE GUN DECK

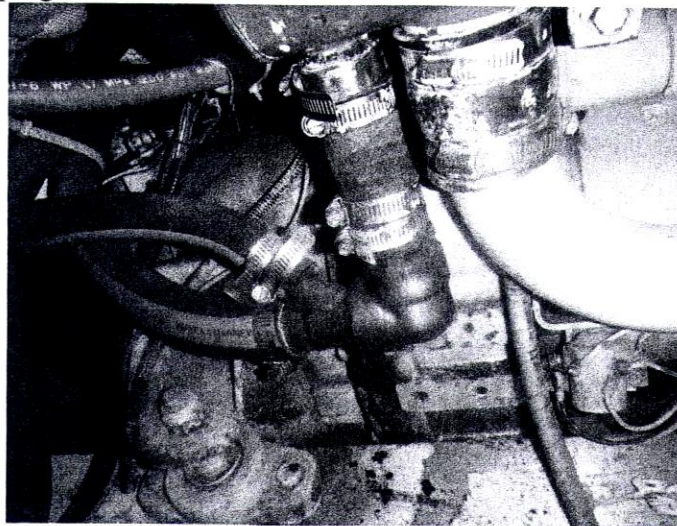
19. On the starboard engine the elbow that runs from the heat exchanger is weeping at the weld.

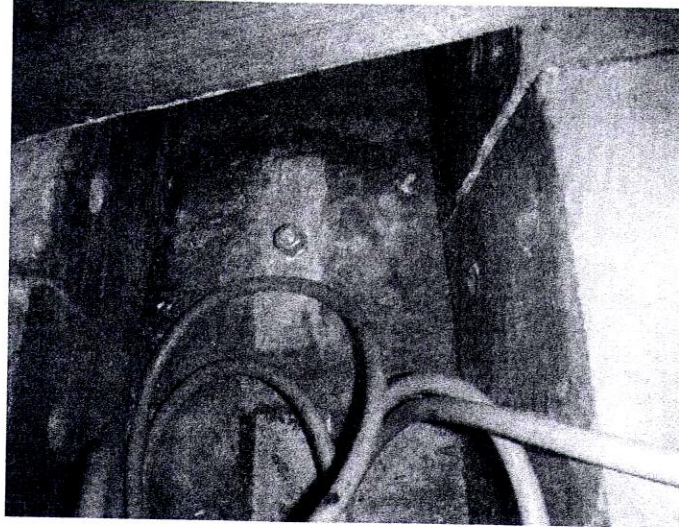
20. The port engine intake hose is starting to get ragged at the pump end. Schedule this hose to be replaced.
21. Around the bolts for the starboard aft end of the shaft tube and the strut bolts the planking has been compromised. These planks will need to be replaced at the next dry-dock. To do this the shaft log and the strut will need to be removed. (+)

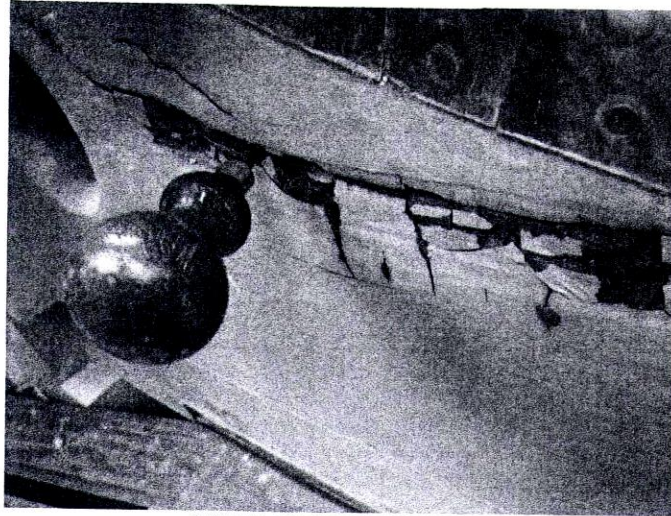
23. The starboard side of the stem knee is significantly rotted. This needs to be replaced as it cannot be determined the extent of the internal damage. (\*)

VIEW OF ROTT IN KNEE

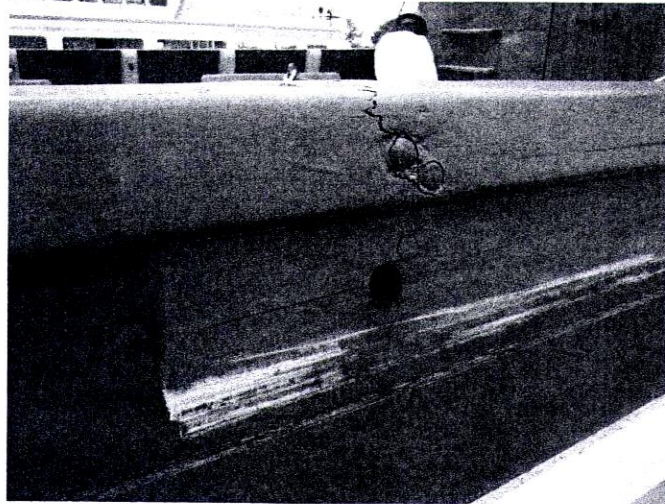
36. On the starboard side stanchions 9 & 11 are significantly rotted and need to be replaced.
37. On the starboard side there are cracks at the bulwark cap rail at stanchion 4 & 5. This is where the gangway secures. The cap rail will need to be replaced in this area.

**CAP RAIL CRACK**

38. On the port side stanchion 5 has a longitudinal split down the center. This is one of the gate stanchions. Replace the stanchion. The port cap rail is split at stanchion #4. This is where the gangway secures. The above three items all are where the gangway lands. It is recommended that this be re-designed. The gangway should land on the coral whale. The section of bulwark above this can be made removable and installed when the vessel is sailing. The present system puts a lot of stress on the bulwarks and the stanchions.

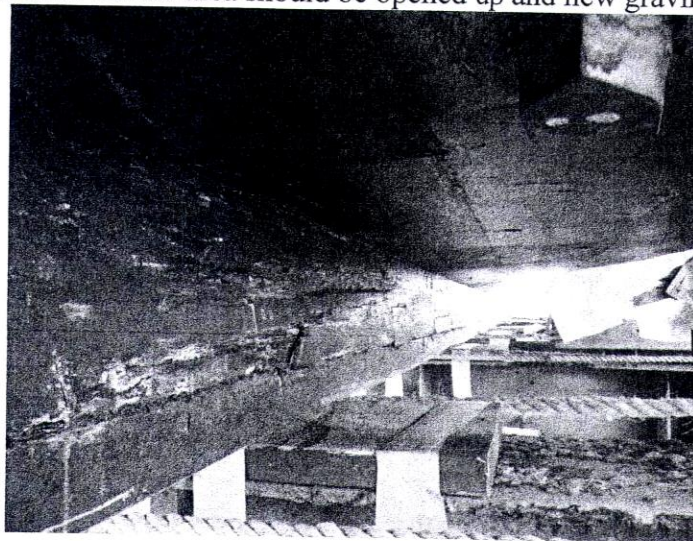
63. On the keel on the port side there has been a keel repair of various graving pieces. These graving pieces have been pushed out over time. Next haul out the area should be opened up and new graving pieces fit.

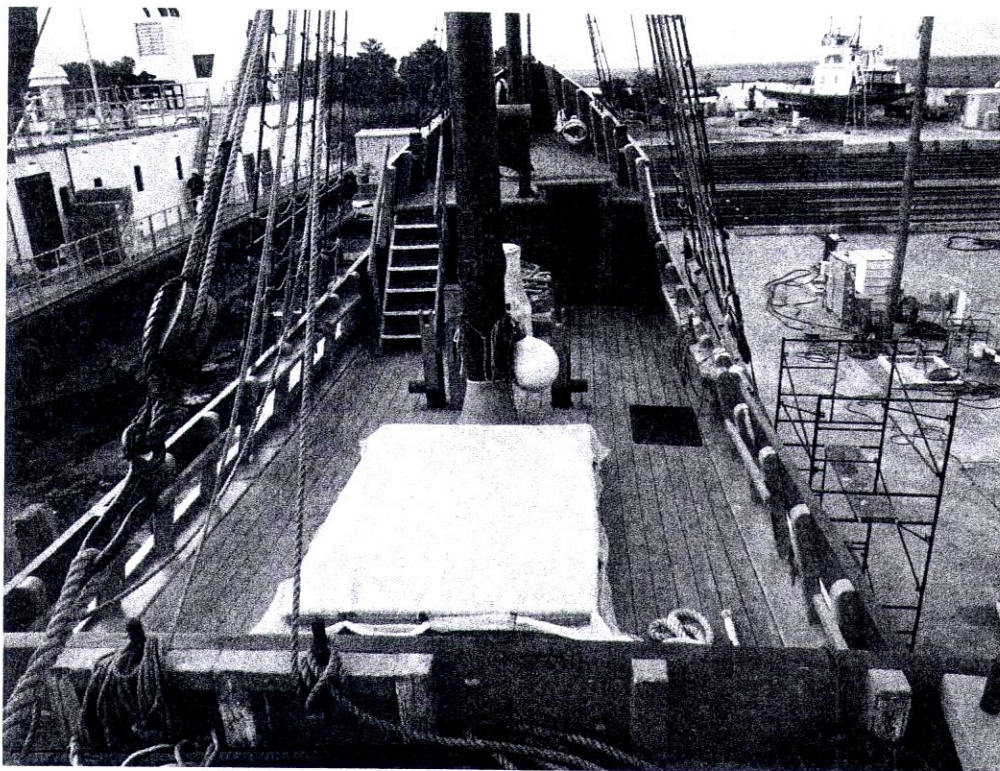
DECK LOOKING AFT – NOTE NEW DECK PLANKS
